Property Condition Consulting

PROPERTY INSPECTION REPORT

Concerning: 1234 My Street, Dallas, Texas
(Address or Other Identification of Inspected Property)

By: Steven R. Cook, TREC 8713 10-6-2010
(Name and License Number of Inspector) (Date)

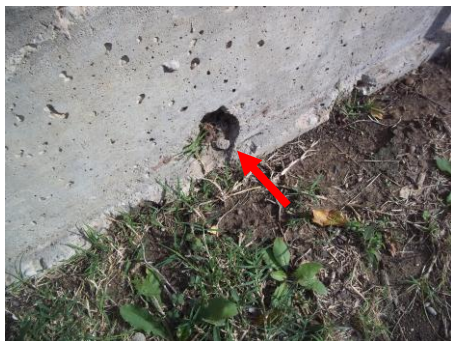
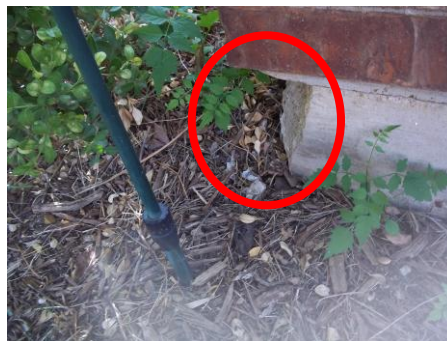
- Corner “pops” or cracks noted at one or more corners, including the back left. These are usually caused by the differential drying and/or expansion of the concrete and brick at the corner and are not a structural concern unless enough of the corner breaks out that the brick is no longer supported. Recommend monitoring.
- Post tension cable ends were observed on the exterior of the foundation along the left side and at the right side. This should be repaired to prevent corrosion.

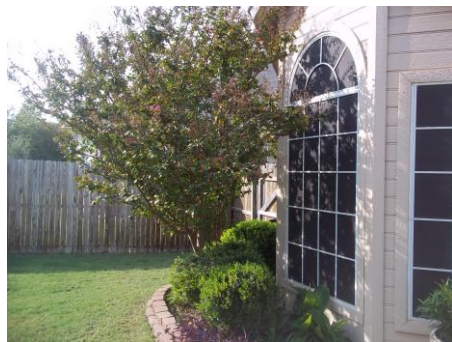
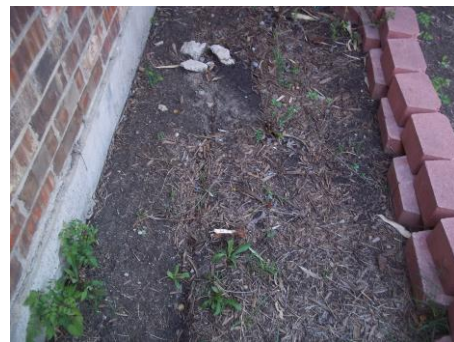
- The tree at the back right is too close to the house. Large bushes and trees close to the home can damage the walls and roof as well as negatively impacting the foundation with their root system by pulling moisture out of the soil. Recommend trimming the tree back away from the house.
- A dripline is developing around the house including along the left and right sides. A dripline can improperly hold water close to the foundation. The addition of guttering to help control water is a good way to prevent further erosion of the soil and maintain the property.
- Soil is washing or settling away from the front left corner. Recommend adding soil to ensure that water drains away from the house and that the foundation is properly supported.

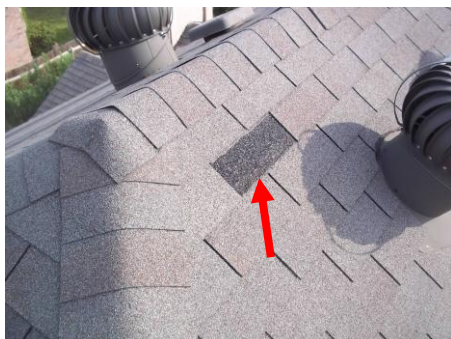
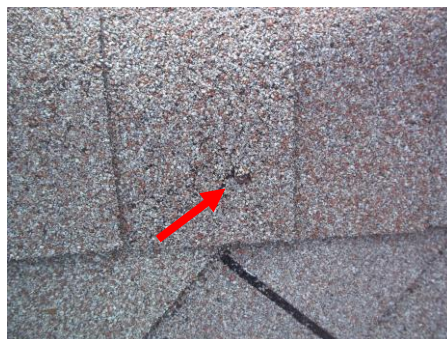
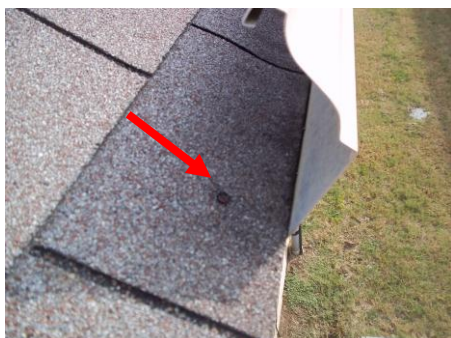
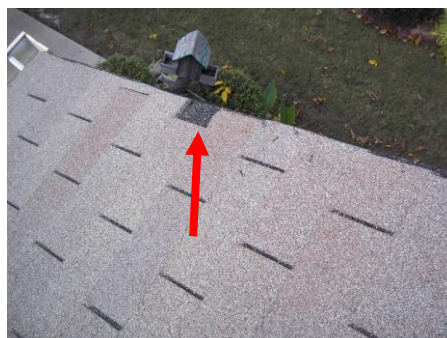
- Observed minor mechanical damage to the several shingles, possibly from a shoe scuff; recommend monitoring to ensure that the shingles do not wear excessively and repairing as necessary.
- Multiple exposed nail heads observed on roof including at the front right ridge and the right side, all exposed fasteners should be sealed to prevent water entry.
- Shingle tabs are missing from the roof, examples include at the right near the top and along the front left. Recommend repairing to prevent further damage or leaks.

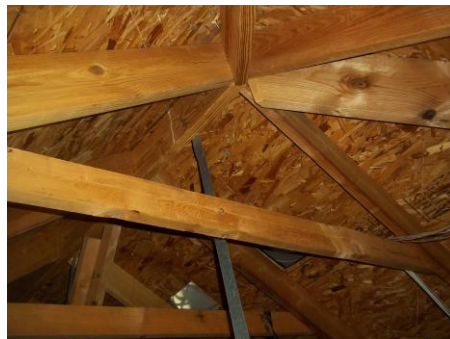
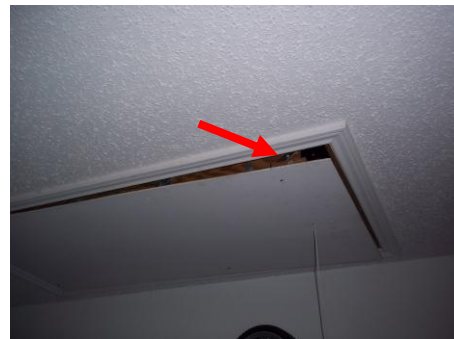
- The attic access ladder does not close properly. Recommend repair so that the ladder closes and seals.

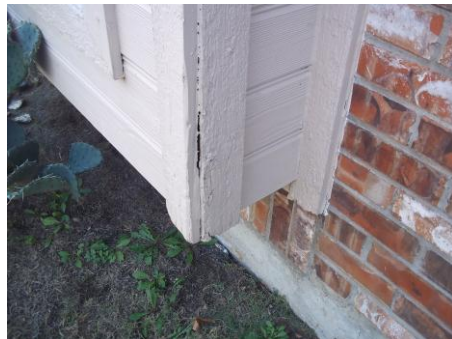
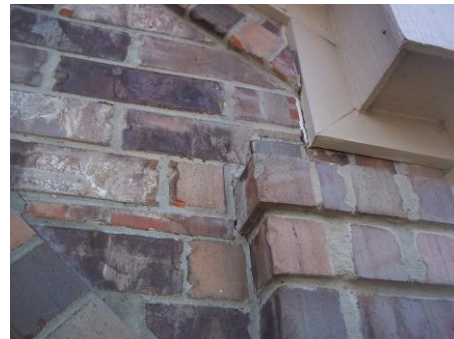
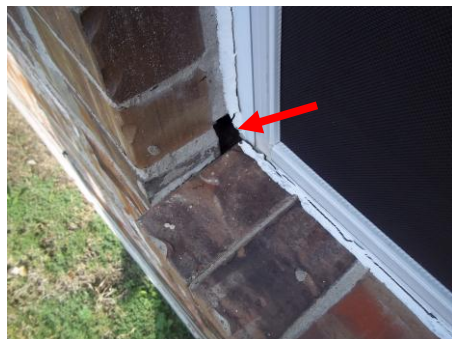
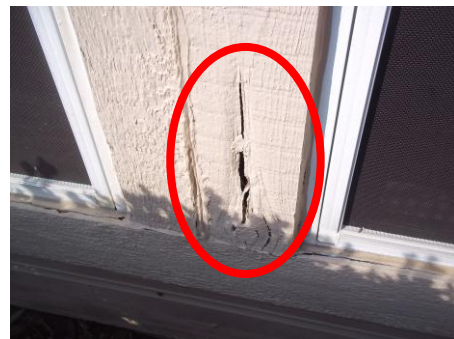
- Observed damage to trim around several windows including the left box window and the back master bedroom window. Damage to wood trim typically cannot be repaired without replacement; however, proper sealing, painting can prevent future deterioration.
- Caulking needed around windows where gaps and holes were observed.

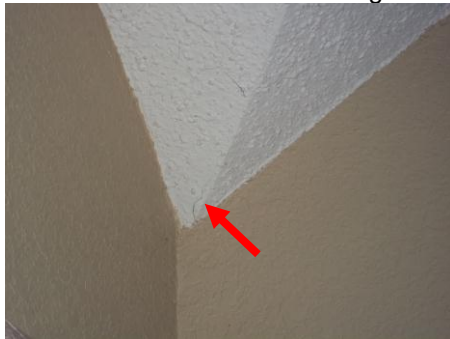
- The home has been recently rehabbed and or updated, including patching and painting of ceilings. Client should be aware that these kinds of repairs can hide issues that would otherwise be visible.
- Ceiling repair noted in the front left bedroom. Consider checking with seller for additional information.
- Nail pops observed on the ceilings in several areas. Nail pops are primarily cosmetic in nature and do not indicate a structural problem; recommend patching.
- Hairline cracks were noted on the ceiling in one or more locations, example(s) include the dining room. This condition is mainly cosmetic in nature and should be patched. Be aware that this kind of cracking is common and will often return over time.

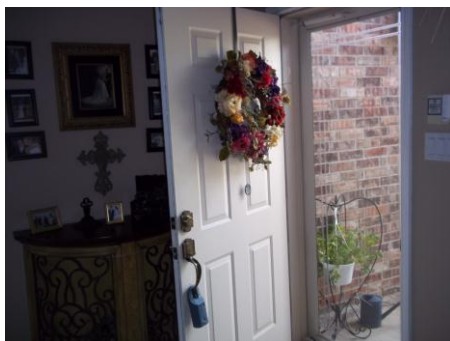
- Doors open, close, and latch or lock properly.
- One or more doors bind or rub slightly when closed, including the front door; while this may be due to settlement a minor adjustment will often address the problem.

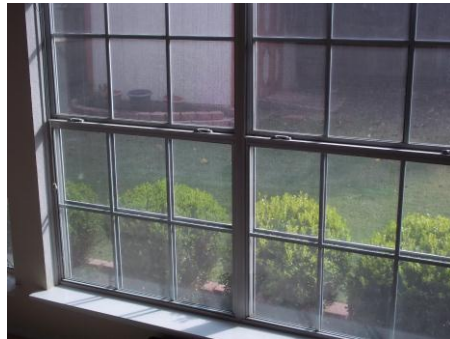
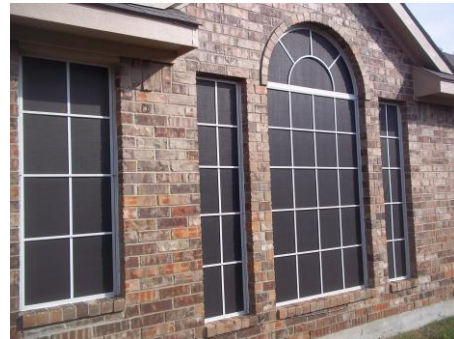
- Window ballast / spring mechanism is damaged or loose, including in the living room and dining room; recommend repair to allow the window to open, stay open, and close properly.

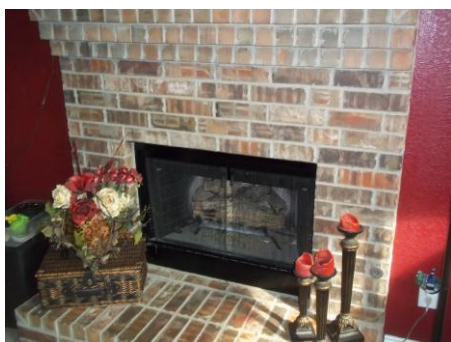
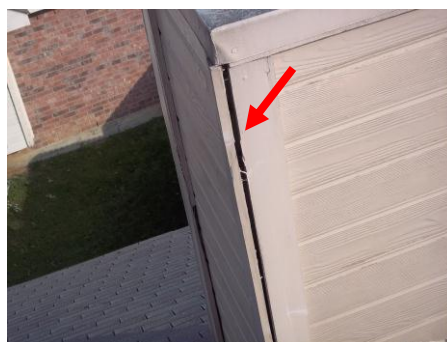
- Damper is missing the required clamp that should be in place when a gas log unit is installed. The damper clamp keeps the damper from closing completely to allow any excess gas to escape up the chimney. Recommend replacing.

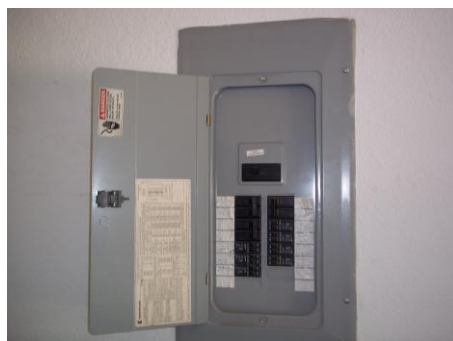
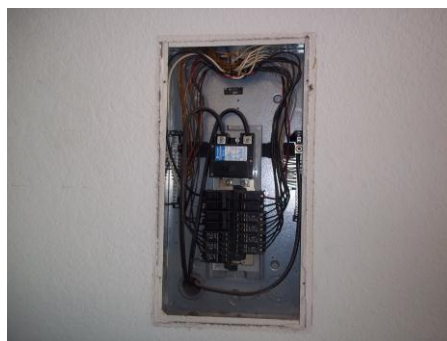
- AFCI breakers (Arc Fault Circuit Interrupters) are not present. Although not required when the home was built they provide some additional fire protection and are now standard on most breakers throughout the house under the 2008 electrical and residential building codes. This item is required to be identified as a deficiency by TREC. **See TREC form OP-I at the end of the report for additional information.**
- Grouping or bunching of the branch circuit wires as they exit the box is common; however, current standards restrict the number of wires that can be grouped for fire protection reasons; recommend repair.
- Neutral circuits within the main distribution panel that are doubled up should be separated.

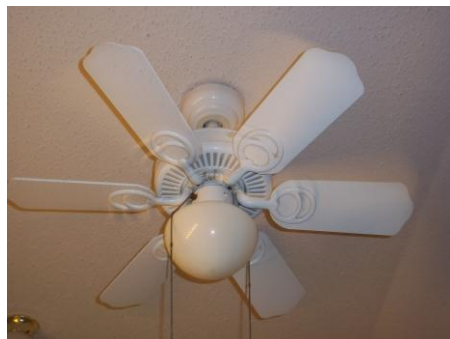
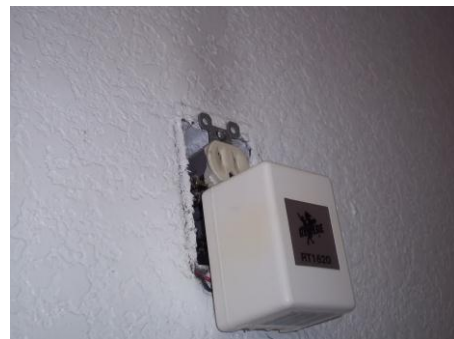
- Some of the lights in the house are controlled by remote. The remote for the light in the dining room is either not available or does not work. Recommend further review and repair if necessary.
- The light on the light / fan in the master bathroom does not work properly; recommend repair.
- The front exterior light is out. If replacing the bulb does not address the problem the circuit should be further investigated.
- Missing outlet cover plates, including in the master bathroom closet, should be replaced.

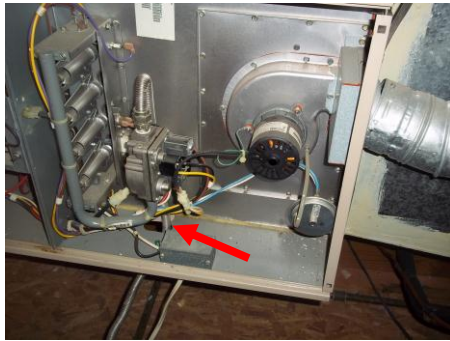
- Flexible gas line extends into the cabinet. Because of the vibrations when the fan is running this gas line can wear resulting in a gas leak; recommend changing for hard pipe.

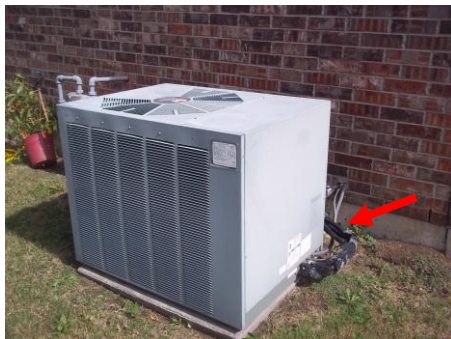
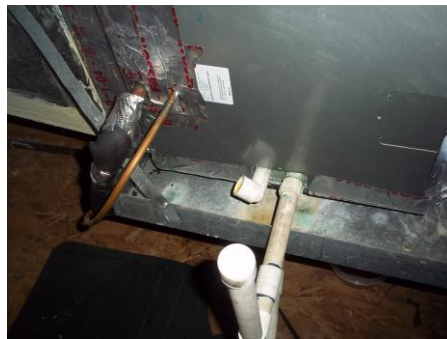
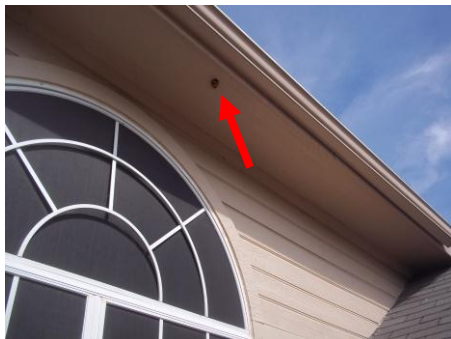
- Cooling system was tested by turning on at the thermostat and taking temperature readings at the intake and register air. The temperature drop measured between the intake and register air is 10 to 12 degrees which is lower than considered typical. This usually indicates that servicing is needed. A qualified heating and cooling technician should be consulted to further evaluate this condition and the remedies available for correction.
- Damaged insulation on refrigerant lines should be repaired.
- The primary condensate drain line for the air conditioner appears to be clogged or not draining. There is water dripping out of the secondary line at the back of the house and the auxiliary drain pan installed below the indoor component of the air conditioning system contains water and debris; recommend further review and repair by a licensed heating and cooling technician.

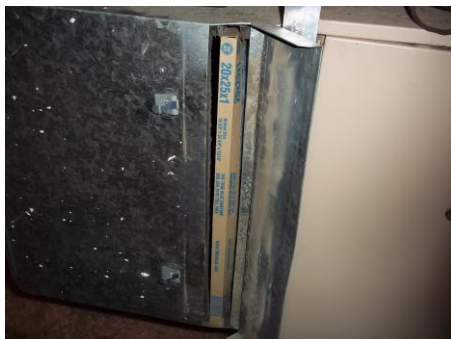
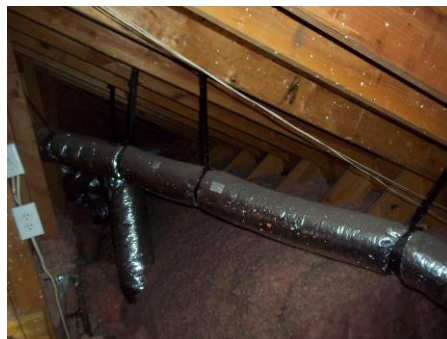
- Filter Size: 20x25x1. The filter is located in the attic next to the air handler.
- Visible and accessible flex ducts are properly strapped and supported in the attic. However; be aware that bends in the ducts can restrict air flow and may restrict the distribution of the conditioned air.

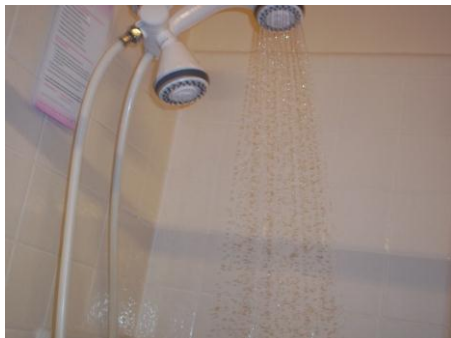
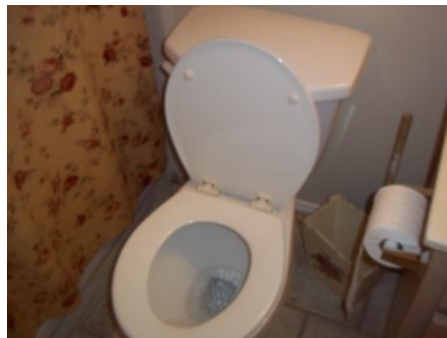
- There is a leak around the hot water faucet at the kitchen sink; recommend repair.
- The drainstop for the tub in the hall bathroom is missing and should be replaced.
- There seem to be some loose tile in the master shower; recommend repair.
- The toilet in the hall bathroom is loose and should be re-secured.

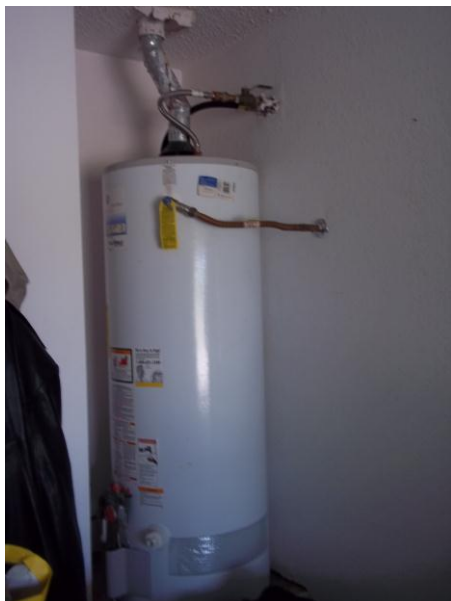
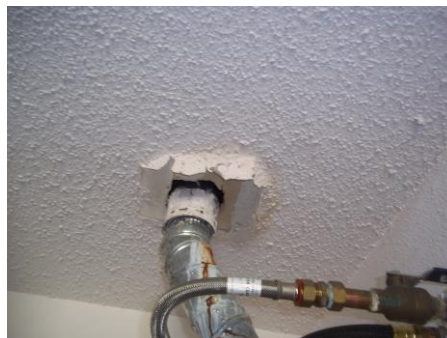
- No safety pan and drain was found for the water heater. Although it may not have been required when the home was built the addition of a pan under the water heater with a drain to the exterior of the home will help to control water in the event of a leak.
- Observed some loose texture and water staining on the ceiling around the vent pipe for the water heater. This may be from condensation or a little leak where the flue goes through the roof. Recommend further review and repair as necessary.

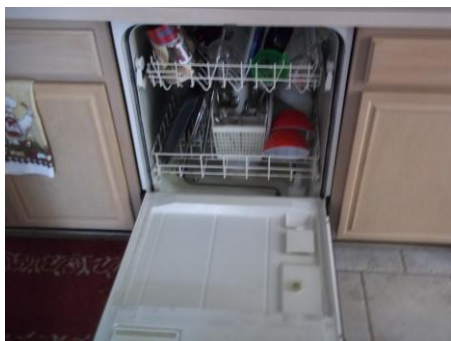
- The dishwasher lacks an airgap or anti-siphon device. Air gaps are now standard equipment to assure a separation between supply and waste water. It is advised that one be installed.

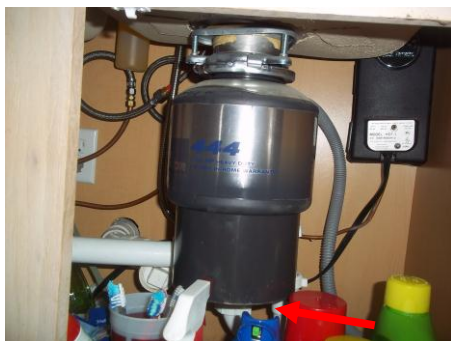
- The collar bracket for the electrical cord on the garbage disposal is missing; collar bracket for the electrical cord protects the wire from rubbing against the side of the unit and should be replaced.

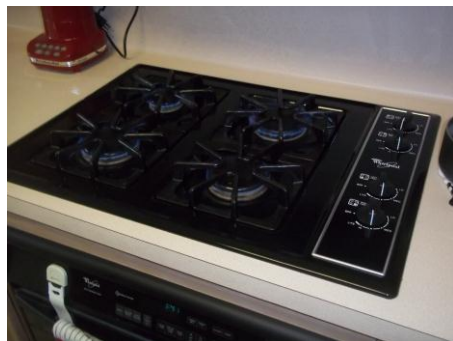
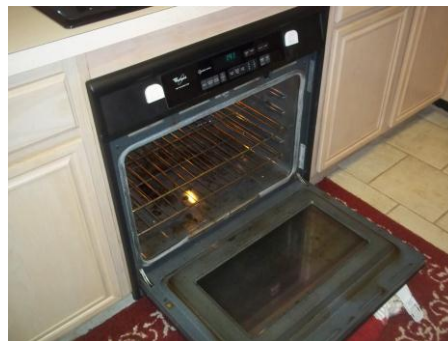
- Cooking burners lit and functioned normally.
- Oven tested and working on both bake and broil.
- Unable to verify that there is a gas shut off for the cooktop because of the household items in the cabinets. Gas appliances should have a shut off in the same room as the appliance.

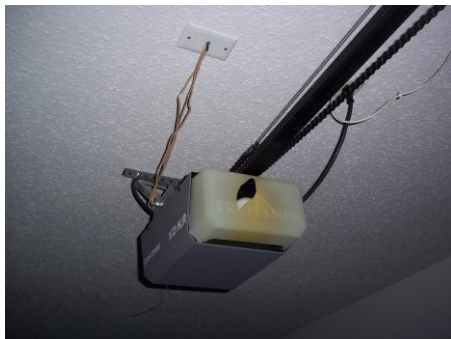
- The light cover on the right garage door opener has been damaged; recommend replacing.
- The left garage door opener did not automatically reverse under resistance to closing, the auto-reverse is missing or not working properly. *There is a risk of injury under this condition.* Recommend repair.

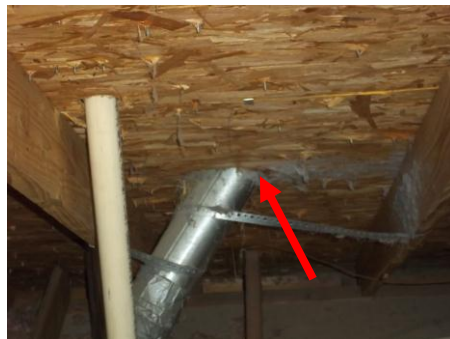
- It appears that the dryer vent may be clogged. Recommend cleaning to prevent a fire hazard.

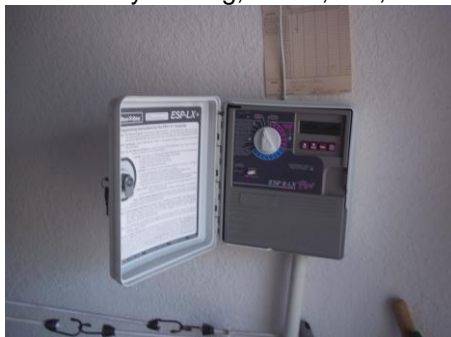
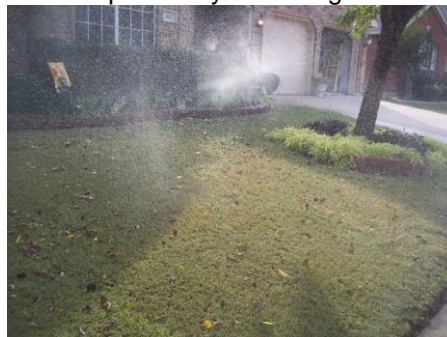
- The sprinkler system was operated in manual / test mode only. There are 7 zones.
- The water spray from the sprinkler system should be re-directed away from the structure and/or any fencing, decks, etc., to decrease the possibility of damage.

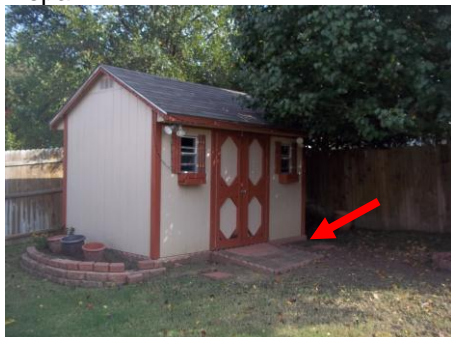
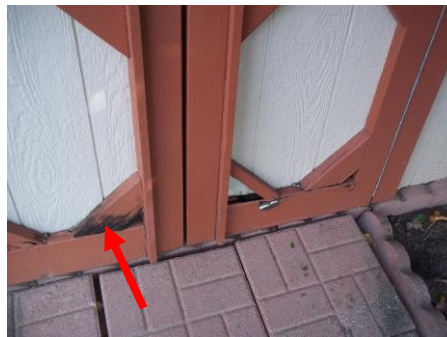
- Deteriorated wood on the door and planter box should be replaced.
- There is less than 6" between the siding and soil; this may be considered a condition conducive to wood destroying insects. Recommend lowering the soil line where possible.
- Exposed wiring in the storage building should be in a protective conduit.
- The outlet in the storage building is not GFCI protected as is now standard. Recommend repair.
