Property Condition Consulting

PROPERTY INSPECTION REPORT

Concerning: 1234 My Street, Dallas, Texas
(Address or Other Identification of Inspected Property)

By: Steven R. Cook, TREC 8713 10-6-2010
(Name and License Number of Inspector) (Date)

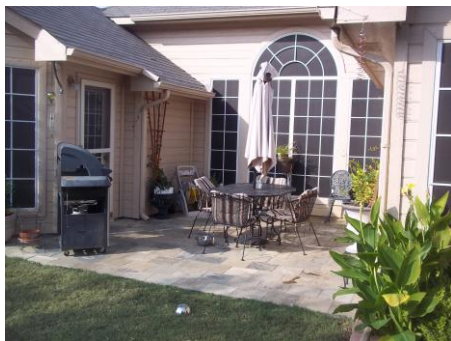
- No structural issues or problems identified with the porch.

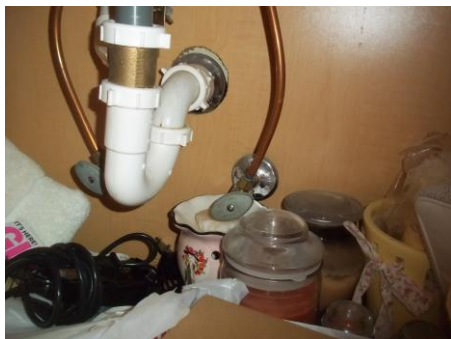
- The main drain clean outs are located at the front left of the house; the drain lines / cleanouts are not opened or inspected.
- No active leaks identified at any of the visible or accessible drain lines.

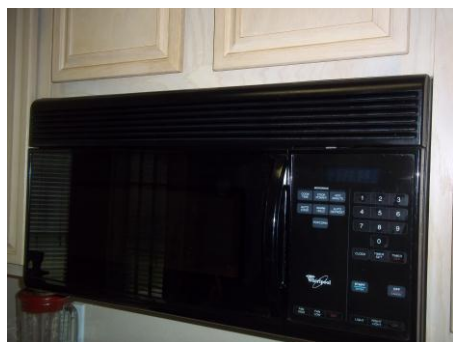
- The microwave was tested by heating a cup of water; it functioned normally.

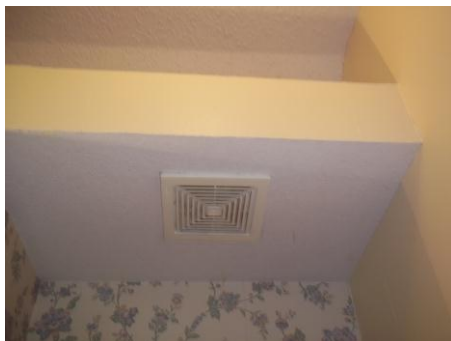
- Vent fans tested and working normally at the time of the inspection.
- There is not a vent fan in the hall bathroom because there is a window.
- Unable to verify that the vent terminates to the exterior of the house.
